NASA Technical Memorandum 81511

**IMPROVED PFB OPERATIONS: 400-HOUR
TURBINE TEST RESULTS**

**Prepared for the
Sixth International Conference on Fluidized Bed Combustion
cosponsored by the U. S. Department of Energy,
the Electric Power Research Institute,
the Environmental Protection Agency,
and the Tennessee Valley Authority
Atlanta, Georgia, April 9-11, 1980**

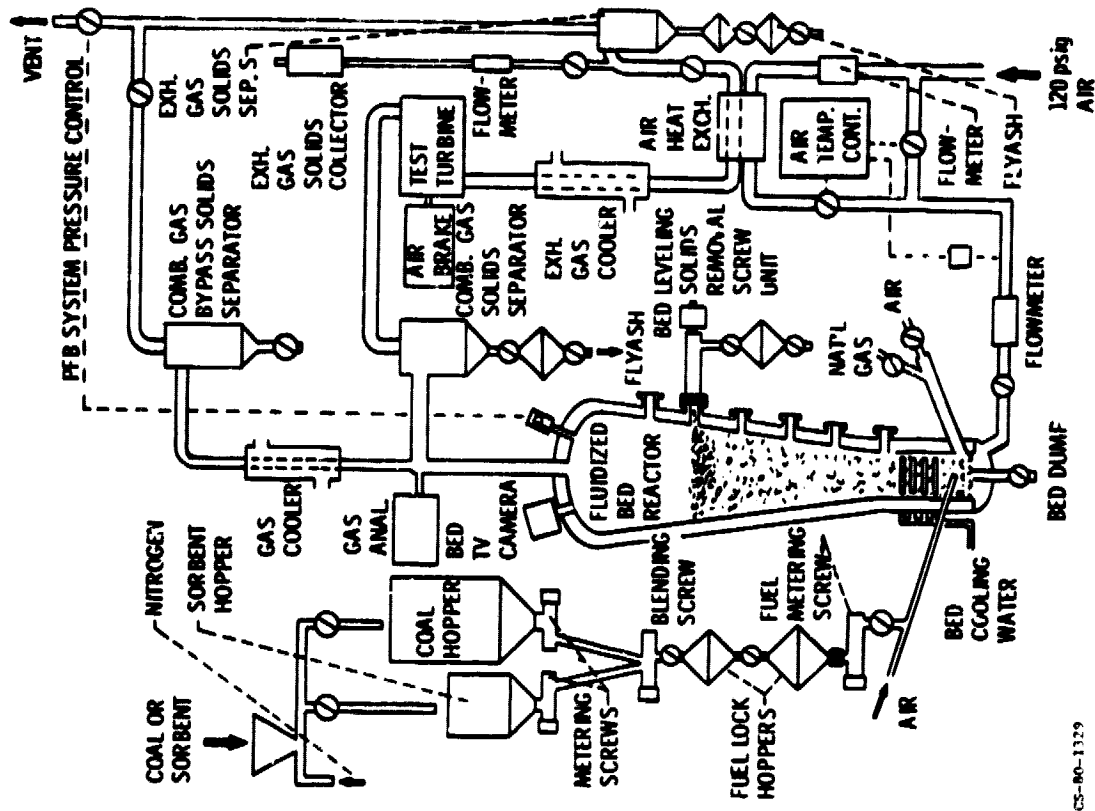
Figure 2 - Schematic of combustion and turbine test systems.

A cutaway view of the PFB test cell is shown in figure 1, and a detailed schematic of the PFB combustion and turbine test systems is shown in figure 2. The combustor (reactor) is about 300 cm (10 ft) high and conical in shape with top and bottom diameters of 47 and 23 cm (19 and 9 in.), respectively. Coal and sorbent materials are stored in hoppers within the test cell and are metered into the reactor. The reactor combustion gases flow through a cleanup system above the reactor before entering the test turbine on the building's top floor. A control room and shop are adjacent to the test cell.

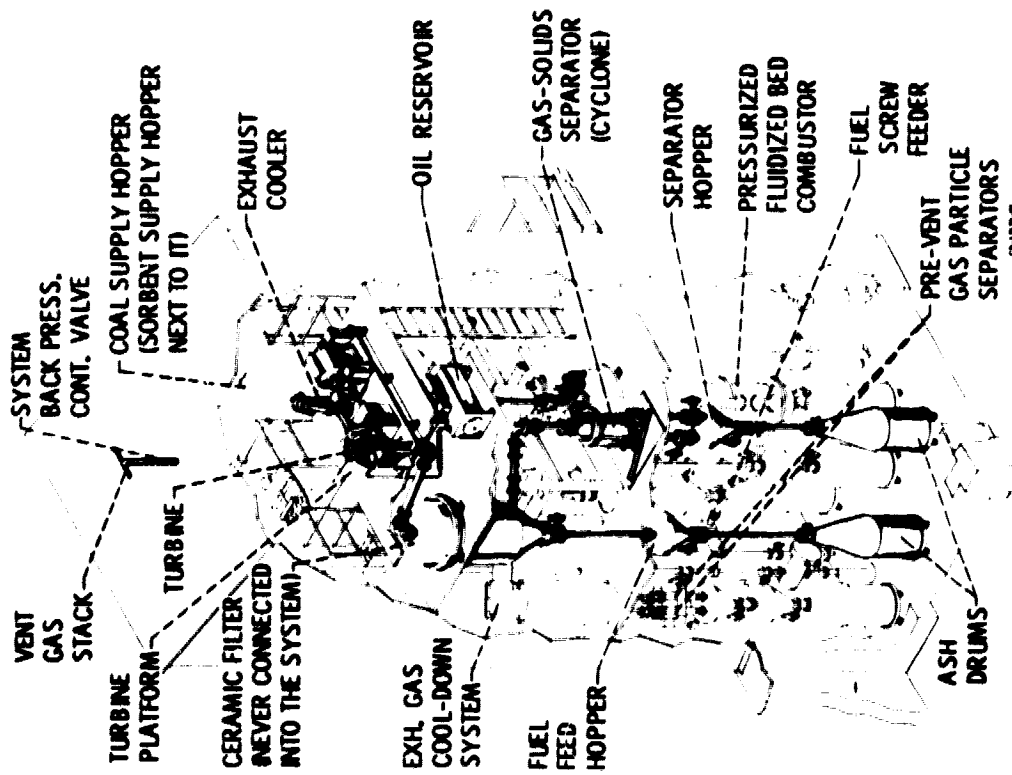
Figure 1 - Lewis PFB test cell.

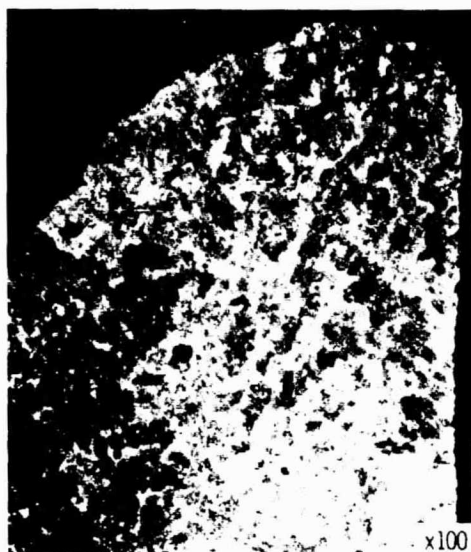
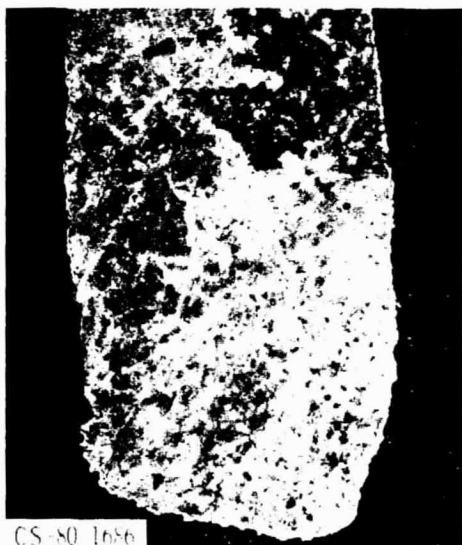
Figure 14. - IN-792 IBT - sulfide and oxide penetration of R7-B blade after 400 hr at 780° C (1430° F) and at 370 ppm (0.2 grain/std ft³) for first 200 hr and 75 ppm (0.04 grain/std ft³) for last 200 hr.

A metallographic cross-section of an R7-B blade after 400 hours is shown in figure 14. Corrosion occurred primarily beneath the most adherent deposit, and visible erosion sites were generally sites of accelerated oxidation but not sulfidation (fig. 15). The penetration of alumina (accelerated oxidation) and one form of sulfur penetration resembled forms seen in previous Lewis turbine tests (ref. 8). This type of sulfidation, seen in R3 blades (Alloy 713LC) at lower average temperatures 704° C (1300° F), is characterized by the presence of atypical chromium-rich oxides and a uniform sulfur front (fig. 16). There appears to be no γ' depletion beneath the front. This morphology strongly suggests either nonequilibrium local PSO_2/PO_2 concentrations or the release of sulfur from surface deposits, since the exact PSO_2/PO_2 concentration required for the simultaneous formation of oxides and sulfides is not likely to occur in these combustion gases.

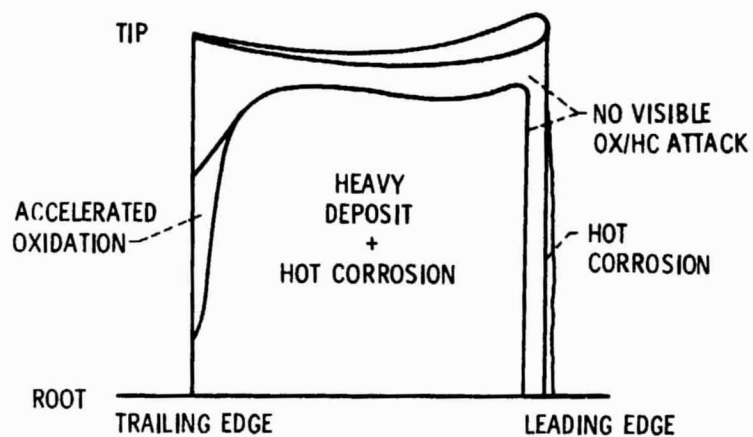
Figure 15. - Suction-side erosion and corrosion of R7-B blades after 400-hr test. CS-80-1678

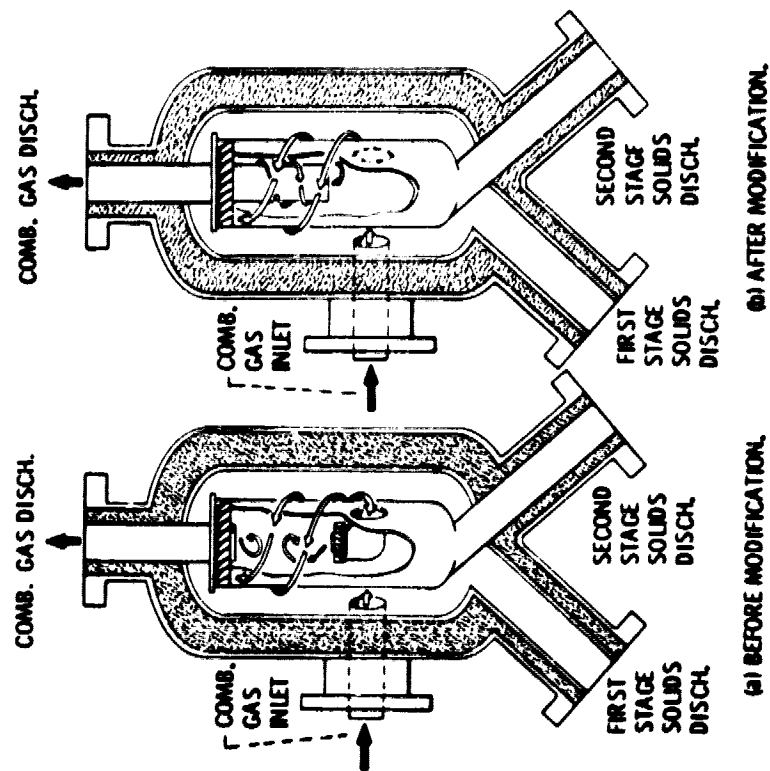
Figure 3. - Cyclone gas solids separator.

The separator was modified so that all the gases traversed the first stage and entered the swirler at the top of the second stage. The exit pipe was extended deeper inside the second stage, thus causing the gases to swirl much further downward before they could change direction and exit the unit. This separator modification increased the gas pressure drop through the unit, but it also increased solids removal efficiency from 25-50 percent to 90-99 percent. Additional cyclone improvements included adding heavier insulation at key areas to minimize heat loss, and packing of internal separator joints to prevent cracking from thermal expansion.

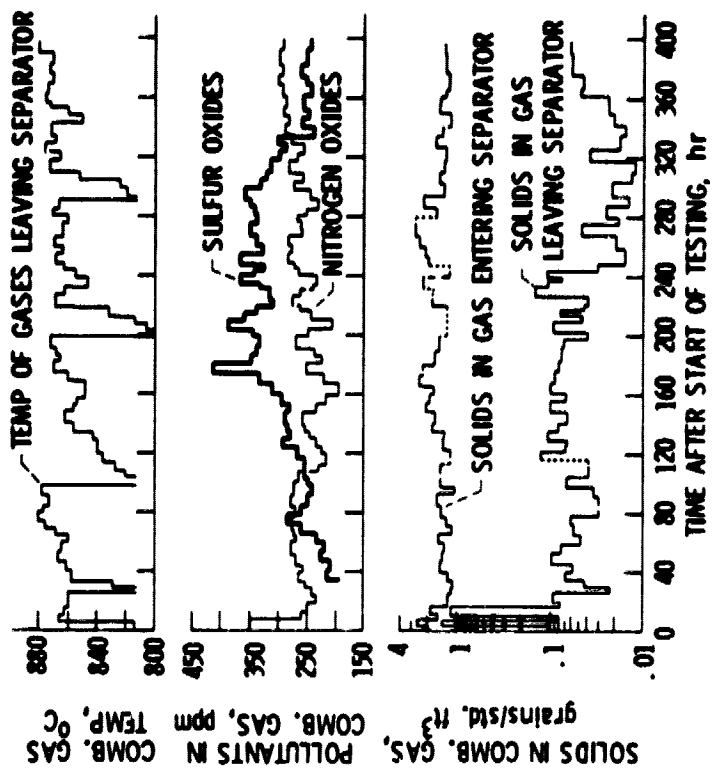
Figure 4. - Variation in gas temperature and pollutants with time.

maximum concentrations did the SO_x emissions exceed the Federal pollution limit of 1.2 lb/million Btu. Figure 4 shows the variation with time of gas temperature and pollutants during the entire test run.

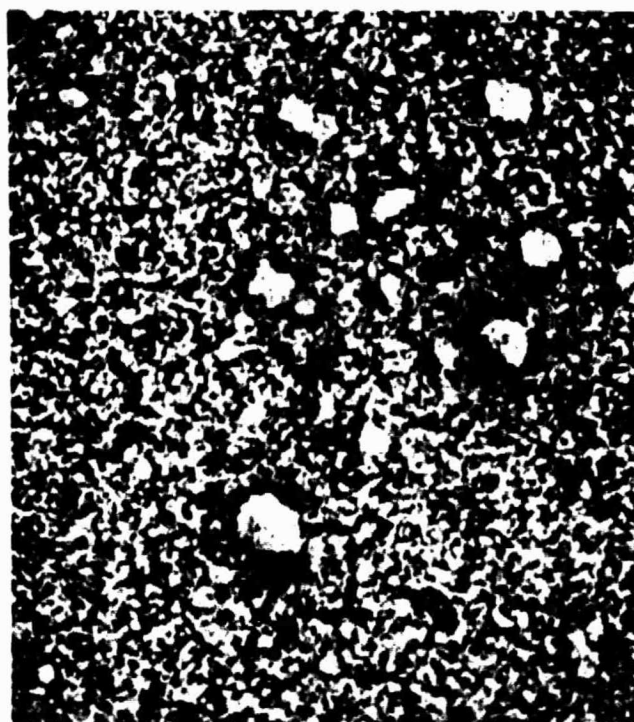
(a) DRY SIEVED FRACTION GREATER THAN 100 μm IN SIZE.

(b) SIEVED FRACTION LESS THAN 100 μm IN SIZE.

Figure 5. - Particles through turbine.

The particle size distribution of solids which passed through the turbine was determined by the Coulter method. Sieving to 100 μm removed debris (>500 μm) which was most likely associated with scale from pipe downstream of the turbine and larger "particles" (100 to 500 μm) which may have agglomerated in the presence of moisture after capture by the separators. Scanning electron micrograph (SEM) examination of particles in the 100 to 200 μm range reflects this compaction of smaller particles (fig. 5). Coulter analyses of the size distribution of particles less than 100 μm in diameter at several loading levels for several weeks during the test are shown in figure 6. The Coulter analysis was performed with a 280 μm aperture tube, and particles less than 4 μm in diameter were therefore not counted. (These small particles pass through the aperture but are not sensed by the electronic system, which is tuned to larger particle sizes.) Particles below 4 μm probably comprise no more than 10 percent of the sample. On the basis of the Coulter analysis, 70 to 80 percent of the particles less than 100 μm in diameter are less than 20 μm as compared with 55 to 80 percent in previous tests. The average particle size was approximately 15 μm .

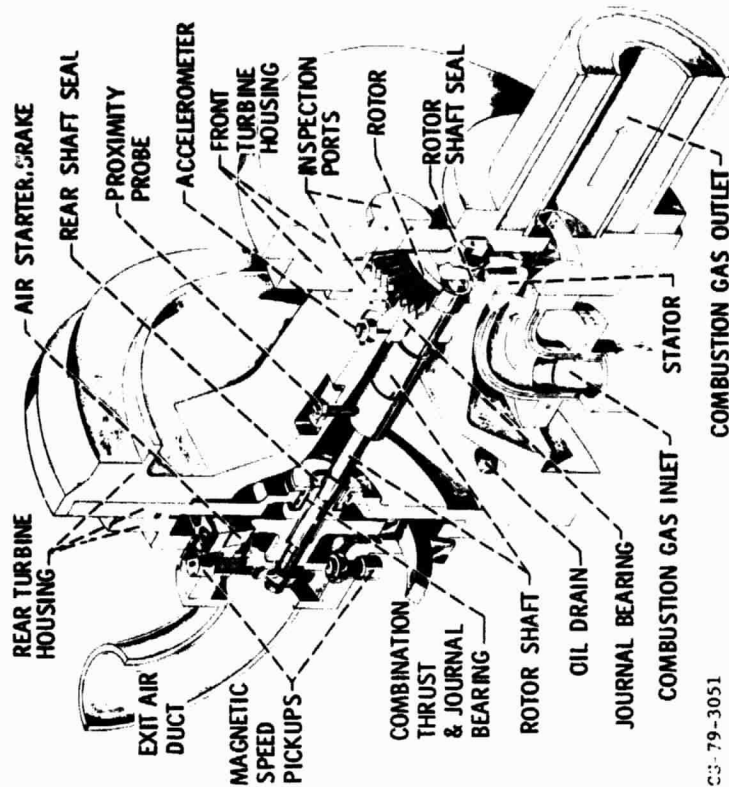
Figure 7. - Isometric section al drawing of turbine.

An isometric sectional drawing of the single-stage turbine is shown in figure 7. The turbine assembly contains turbine components in two subunits - the front and rear housings. The front housing consists of two Hastelloy flanges that form the cavity in which the rotor turns. The hot combustion gas enters the turbine through the single stator passage, expands in the rotor cavity, causing the rotor to turn, and exits the turbine through the flange opening shown in the figure. Two inspection ports permit visual examination of the rotor's leading and trailing edges during test downtime.

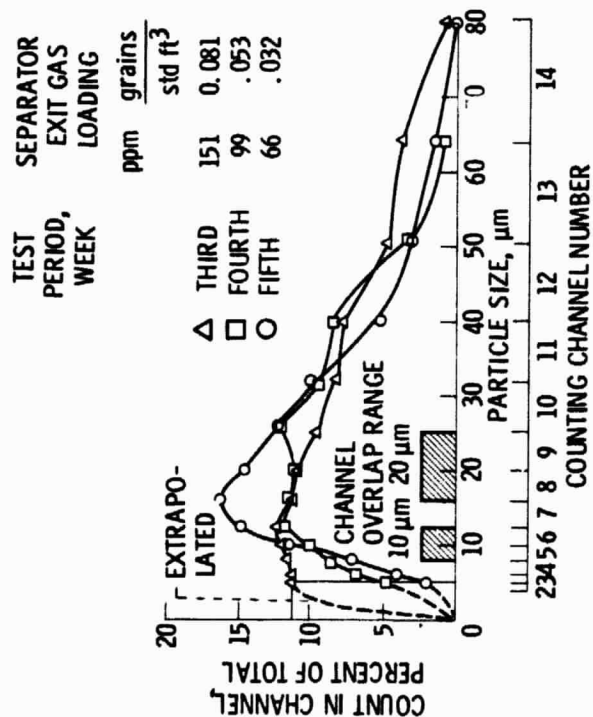
Figure 6. - Particle size distribution by Coulter analysis. (Solute: 80 percent ethanol, 15 percent glycerin, and 5 percent LiCl by weight.)

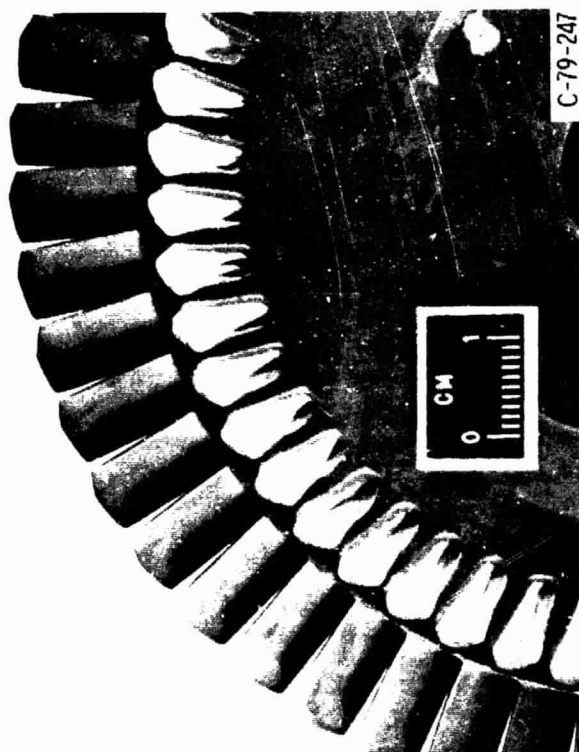
Figure 8. - Erosion of R5 rotor blade tips after 12 hr at 780° C (1440° F) and 2600 ppm (1.4 grains/std ft³).

400-hr test (R7). Figure 8 shows loss of the trailing edge tips of R5 blades after 12 hours.

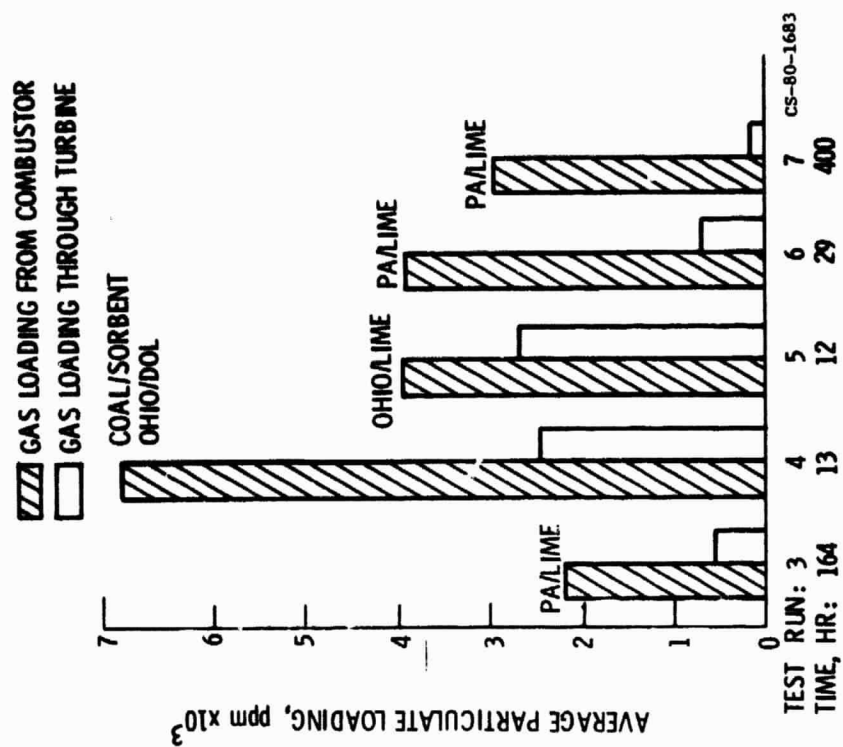
Figure 9. - Combustion gas solids cleanup.

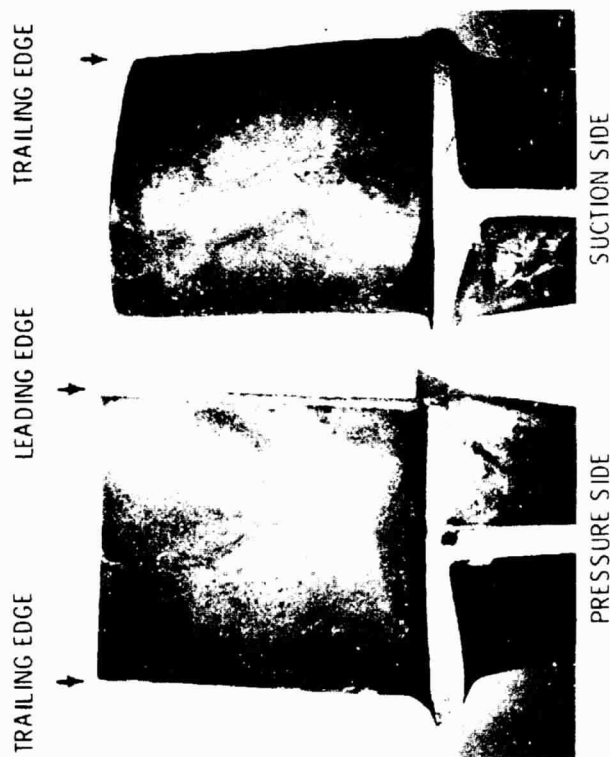
Figure 12. - Surface appearance of R7 rotor after 400 hr at 780° C
 1430° F and 180 ppm (0.1 grain/std ft³).

The appearance of the R7-B blades after 400 hours is shown in figure 12. Adherent deposits covered the suction side and occurred primarily near the leading edge on the pressure side. Some evidence of heavy particle bombardment was visible at the trailing edge tip and near the center on the pressure side. However, the trailing edge tips were still structurally sound in contrast with the R5 blade tips. The maximum surface erosion loss was 0.15 mm (6 mils) at the leading edge, and the average erosion loss over the surface was 0.025 mm (1 mil) (fig. 13). From the average surface loss rate the projected full admission erosion rate at this loading and particle velocity is about 2 mm/1000 hr (70 mils/1000 hrs).

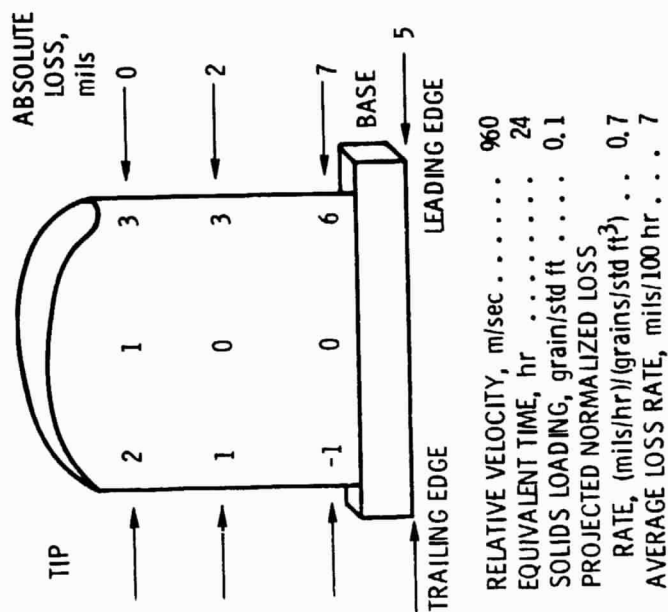
Figure 13. - IN-792 + Hf IBT - erosion loss of R7-B blades after 400 hr. Projected for full admission.

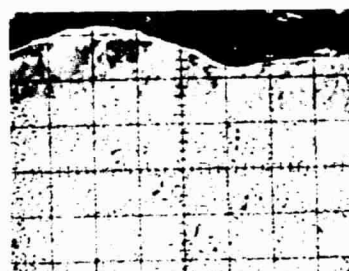
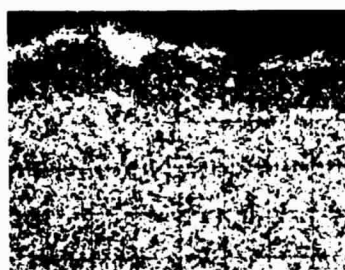
ELECTRON MICROPROBE ANALYSIS

Figure 17. - IN-792 + Hf JBT - sulfidation of R7-B blades after 400 hr at 780° C (1430° F) and at 370 ppm (0.2 grain/std ft³) for first 200 hr and 75 ppm (0.04 grain/std ft³) for last 200 hr.

The morphology of another form of sulfidation on R7 blades is shown in figure 17. Nearly spherical chromium sulfides are seen in a nickel-rich depletion zone (~10 μ m) beneath a very thin (~3 μ m) surface oxide layer (ref. 13). This morphology closely resembles other forms of sulfidation in which the presence of molten phases can be detected. The presence of sulfidation after 400 hours but not after 200 hours may reflect a

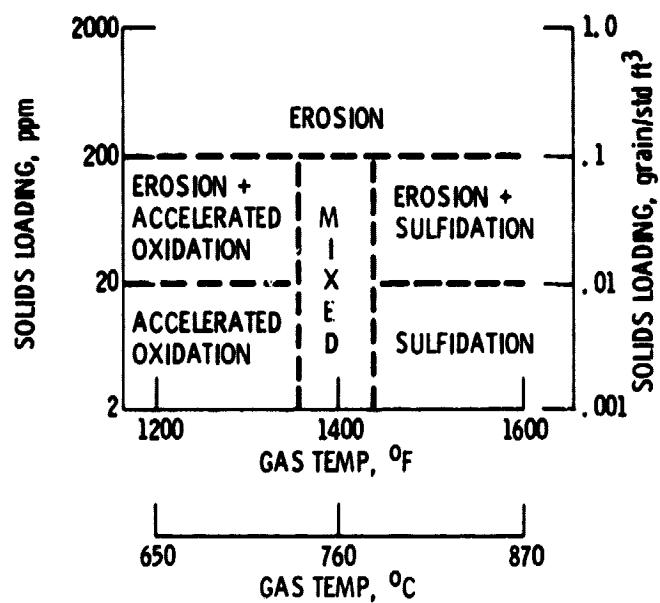
Figure 20. - PFB turbine projected life-limiting mechanisms. Gas velocity, 300 m/sec (1000 ft/sec).

On the basis of test R7 and previous rotor results, it appears that a severe form of superalloy corrosion can be initiated by the effluent of a PFB. This form may contain a liquid phase, and the onset may be related to reduced erosion rates and possibly an incubation period. Figure 19 shows the relative importance of corrosion and erosion in three of the previous tests. As solids loading (and thus erosion rate) is reduced, corrosion penetration becomes equal in importance to erosion as a source of material damage. The crossover point, that point at which they become equally important, appears to be at a solids loading of about 100 ppm (0.05 grain/std ft³) for relative gas velocities of about 300 m/sec (1000 ft/sec).

At still lower erosion rates (<0.25 mm/1000 hr; 10 mils/1000 hr), the predominant material damage mechanisms are likely to be accelerated oxidation and sulfidation, with blade temperature distribution, deposition pattern, local erosion rate, and time, determining the nature of the local attack (fig. 20). Future research should continue to focus on attempts to reduce particulate loadings and average particle size to reduce erosion. In addition, efforts should also be placed on determining corrosion-resistant coatings and materials for PFB applications in order to minimize the damage of oxide and sulfide penetration.
